IR Thermography In The Building Science Industry

Scott Wood & Bill Weber

Four Star Cleaning and Restoration, Inc. a Disaster Kleenup International Member

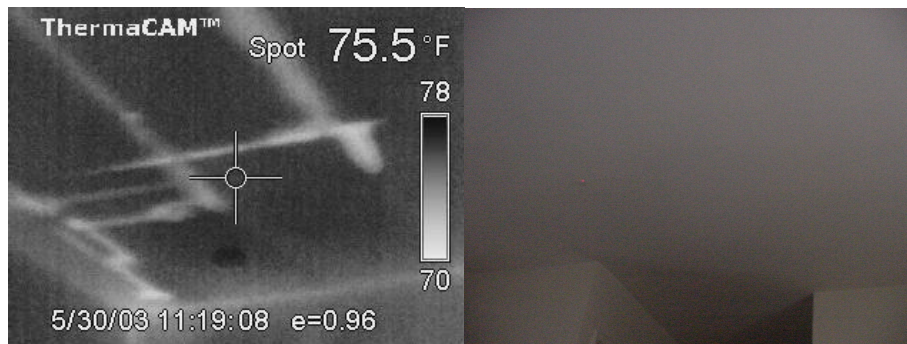
Figure 1. Thermogram/photo pair showing moisture detected on a ceiling (lighter areas).

Figure 1 shows the IR image of the ceiling after the test. The lighter images indicate cooler wet sheetrock. A non-destructive moisture meter was used to confirm the presence of moisture where indicated by the IR imaging. At the beginning of the water test, moisture intrusion was visible beginning at the edge of the ceiling and not in the center of the ceiling where the water staining was first visible.

Further examination of the areas above the room revealed a failed door threshold just above the discovered intrusion point. Without the IR camera we would have first removed the ceiling of the bedroom at the location of the water stain to pinpoint the water intrusion point. Because the actual leak was not directly above the stain it would have been difficult to pinpoint the source. When using the IR camera in conjunction with the water test we were able to pinpoint the water source without needing to open the ceiling, and possibly missing the entry point altogether.

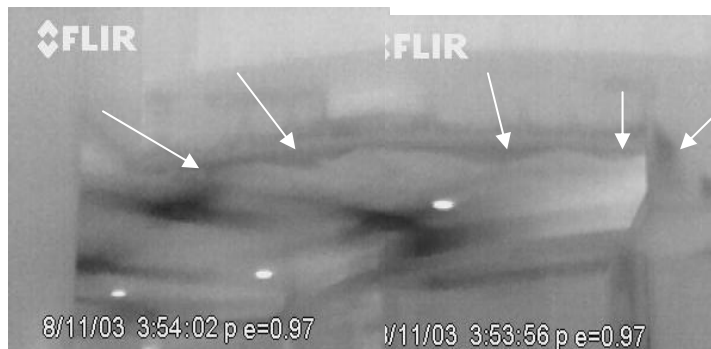
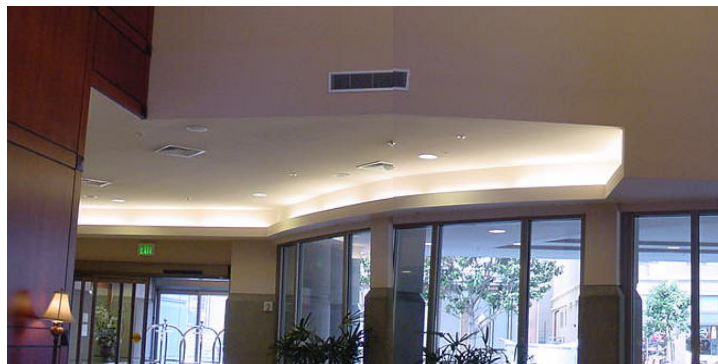
A water pipe broke on the third floor of a hotel, sending water throughout the third floor and the two floors below. Four Star's water division was called to perform emergency services on the water-damaged structure. A quick IR camera survey of the three floors was performed allowing for a quick determination of the affected areas to evaluate swift and efficient placement of drying equipment. One area of the hotel that was of concern was the lobby ceiling. The ceiling was at a height and location that prohibited direct moisture testing using standard non-destructive and penetrating moisture meters. Ladders would have blocked entry and the procedure would have required a considerable length of time to adequately survey the whole lobby ceiling. As shown in Figure 2, within minutes moisture was located in the lobby's ceiling using the IR camera. Because the specific areas of the ceiling could be determined so quickly and precisely, we were able to place drying equipment only in the areas needed to safely dry the areas involved.

Figure 2. Thermogram/photo pair showing moisture detected on the ceiling of a hotel lobby.

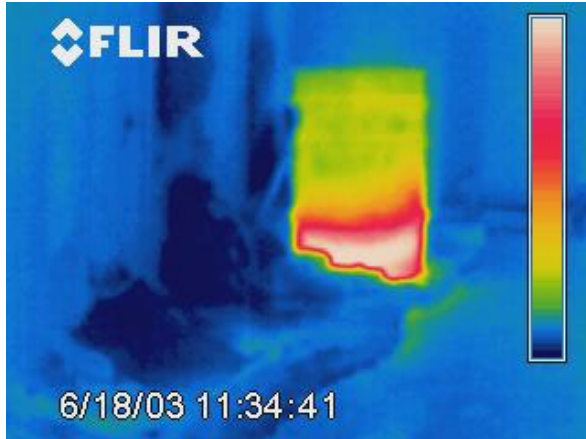
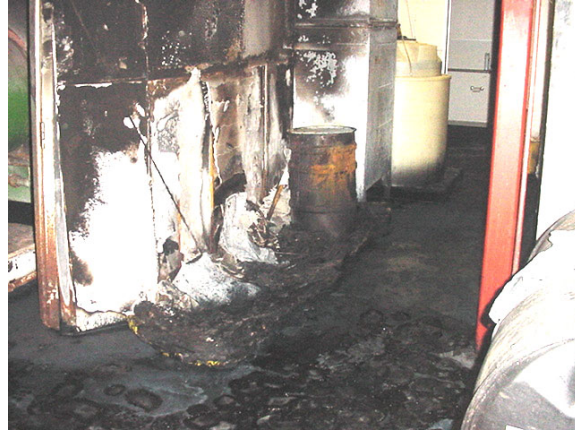
Fire occurred at a garment dying facility. We were called to perform emergency services and were on-site about 10 hours after the fire was knocked down. An infrared (IR) thermographic inspection revealed a potentially explosive drum of sodium hydrosulfite that was still hot hours after the fire was extinguished. Figure 3 shows the 32-gallon drum still sitting in the ashes of the fire. Water reacts with sodium hydrosulfite to produce poisonous hydrogen sulfide gas, and enough heat to cause spontaneous combustion and a potential explosion in the sealed container. A hazardous waste hauler, the fire department, and HAZMAT were called and disposed of the drum, preventing a possible catastrophe.

Figure 3. Thermogram/photo showing the heated sodium hydrosulfite in a 32 gallon drum.
