## Conducting a Whole House Inspection for Latent Fastener-into-Pipe Defects Using Visual and Thermal Information

*Ken VanBree – Imaging Perspective, LLC  
Scott Wood – Building Sciences Institute*

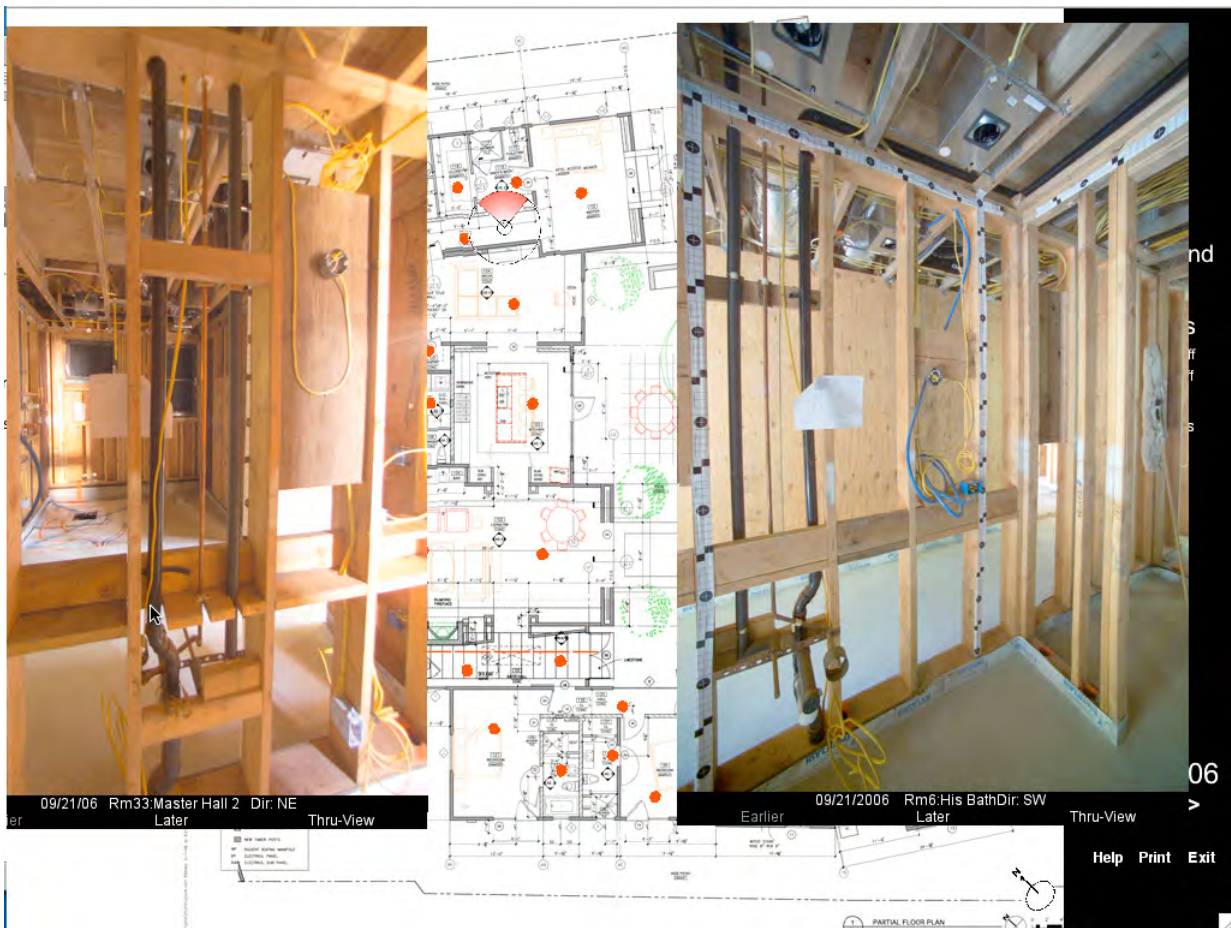
Figure 1. Screen shot of Imaging Perspective's viewer showing piping in bathroom from both sides of wall.

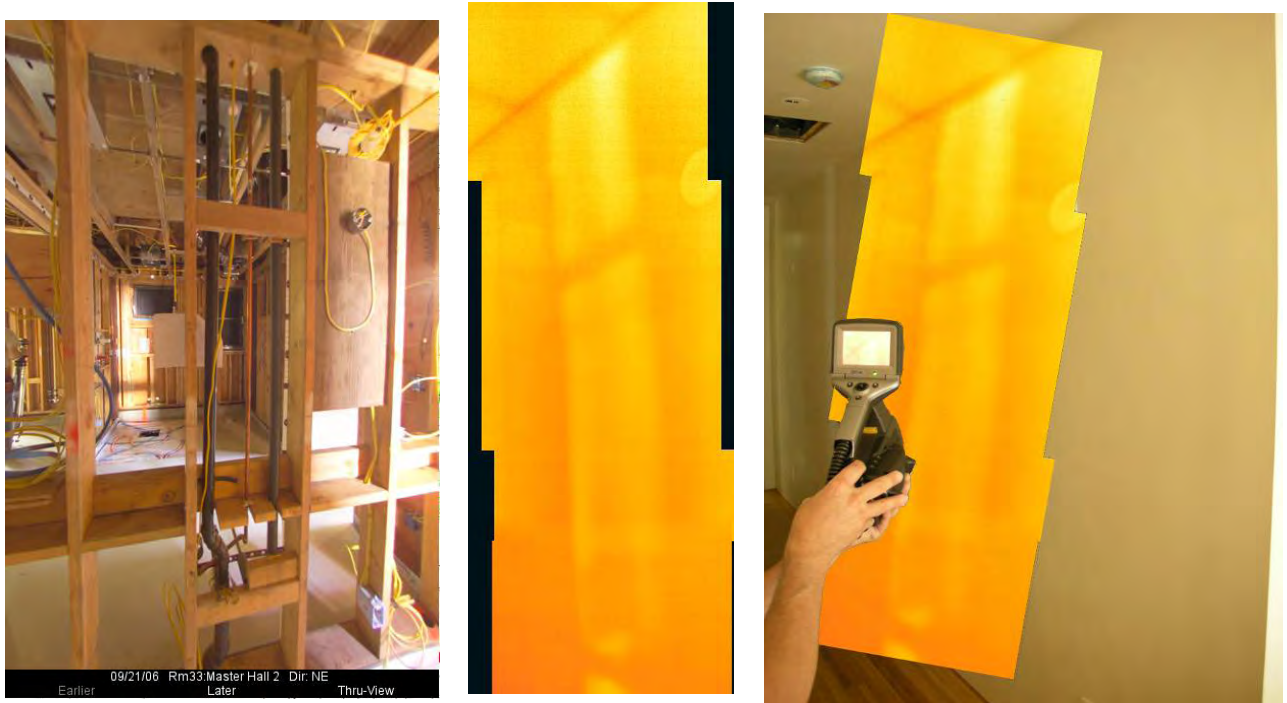
*Figure 3. Visual and thermal images of vent pipe (leftmost pipe in stud bay) and hot-water pipe (rightmost pipe)*

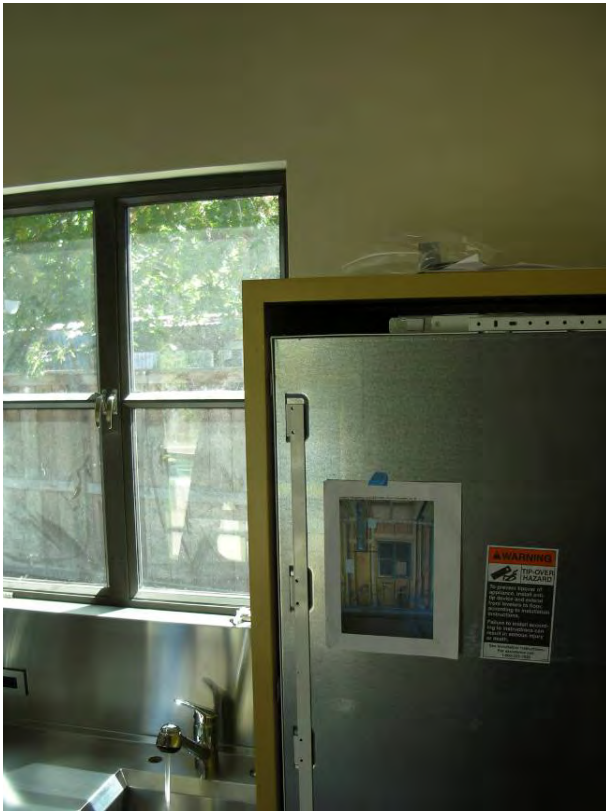
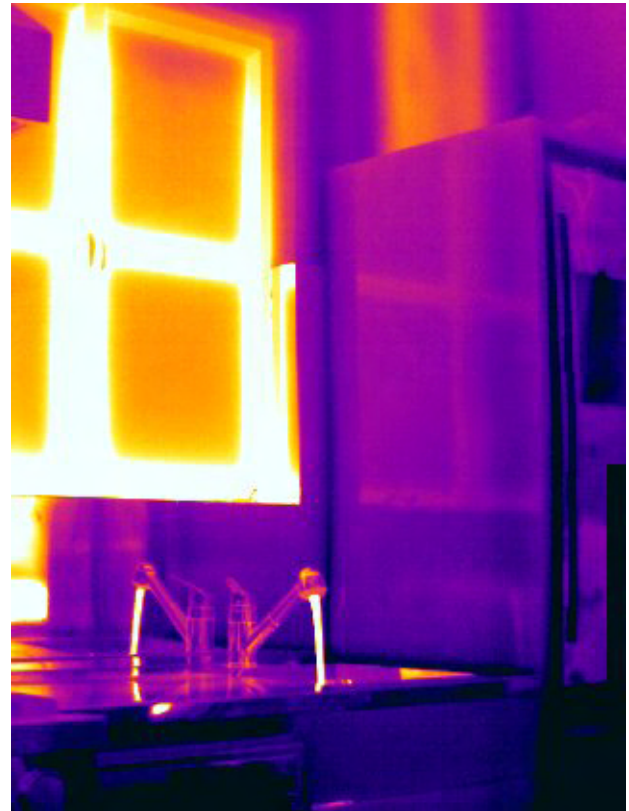
Figure 4. Hot water feed to kitchen blocked in some areas by cabinetry and stainless steel backsplash.

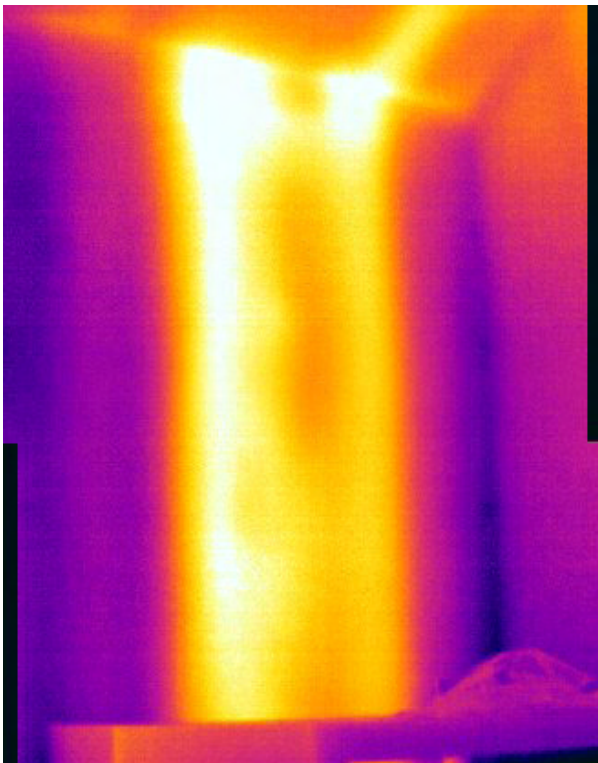
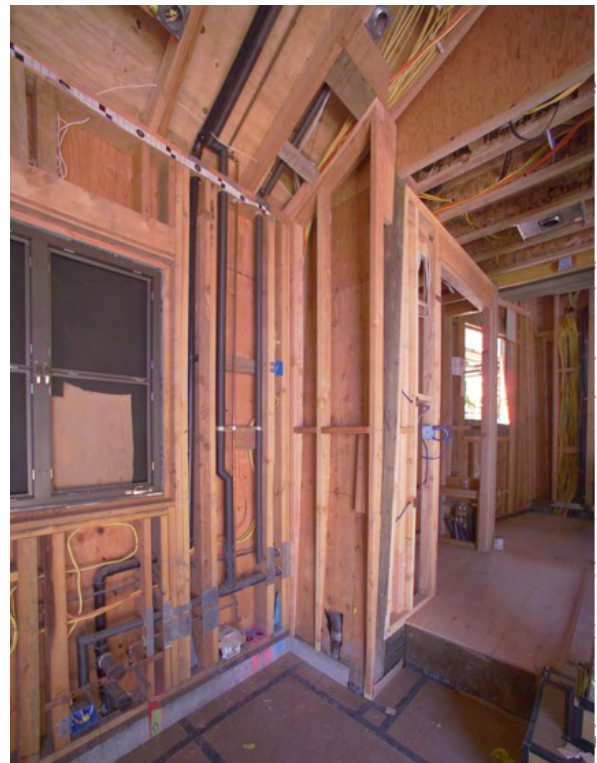
Figure 5. Detail of piping above refrigerator in kitchen. Hot water and vent exit on left. Right pipe is radiant heat.

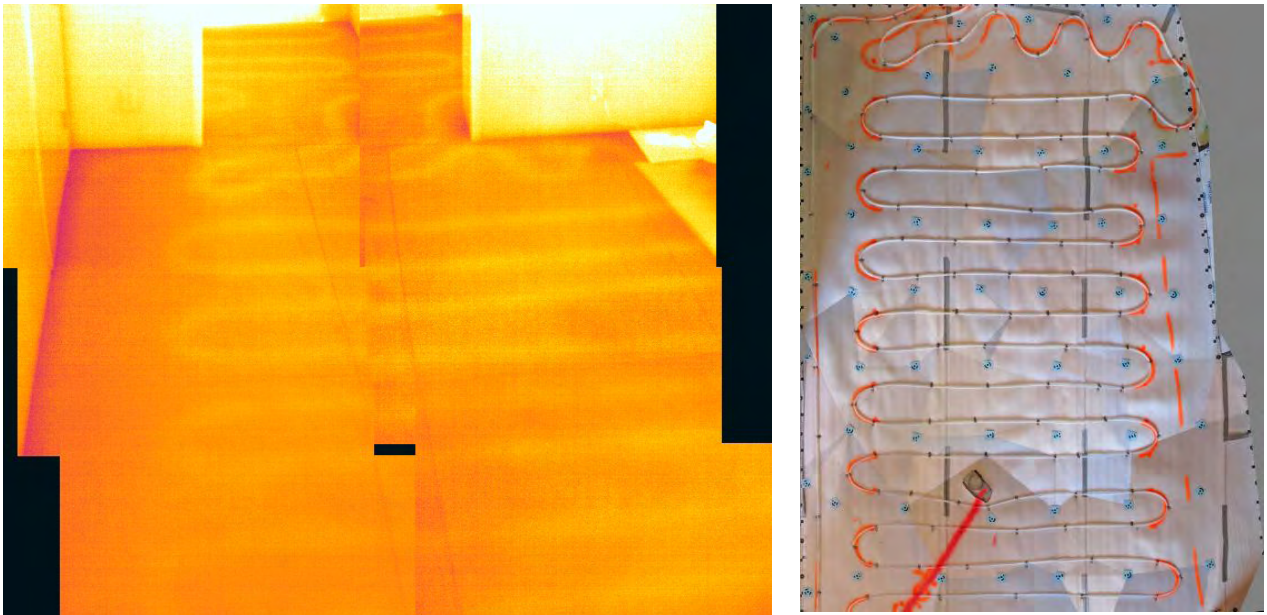
*Figure 6 Thermal and visible-light images of a portion of the hydronic heating system of the home*

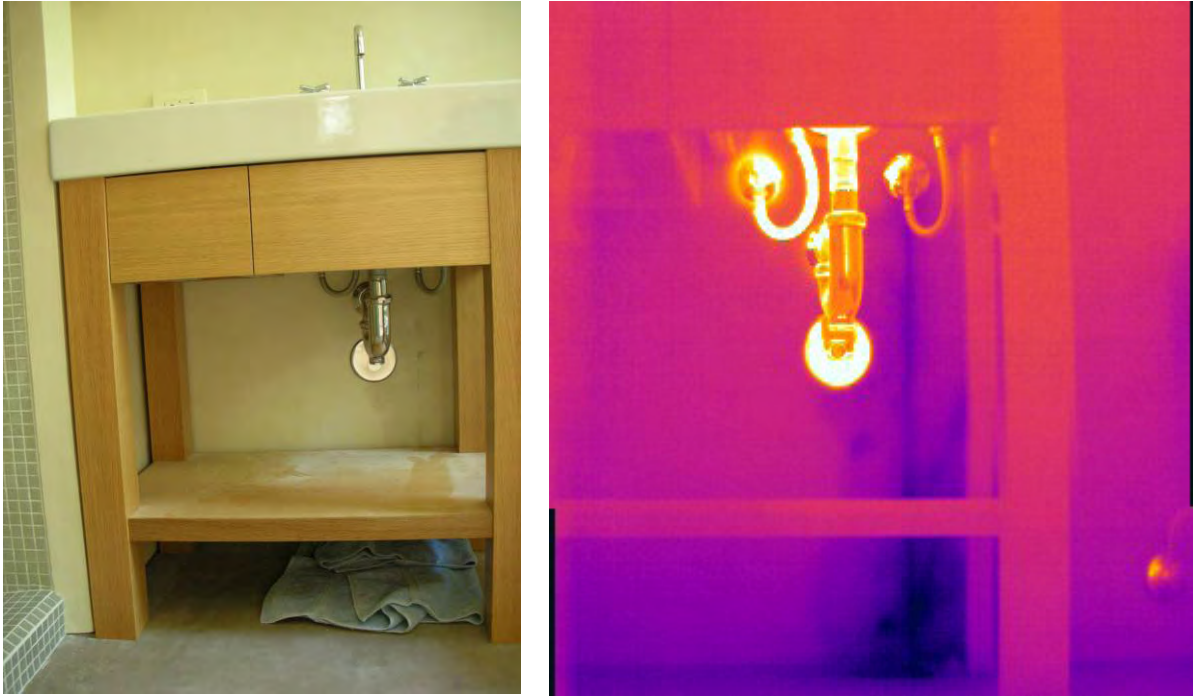
*Figure 7 Visual and Thermal images of leak at angle stop of cold water line feeding bathroom sink.*
