Detection of Moisture within Building Enclosures by Interior and Exterior Thermographic Inspections

*Antonio Colantonio, Public Works and Government Services Canada
Scott Wood, Building Science Institute*

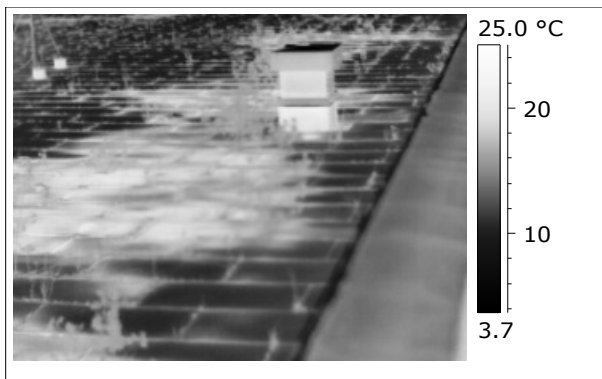
Figure 1. Infrared image of moisture within concrete clad insulation over inverted roof membrane, $T_o = 20^{\circ}\text{C}$

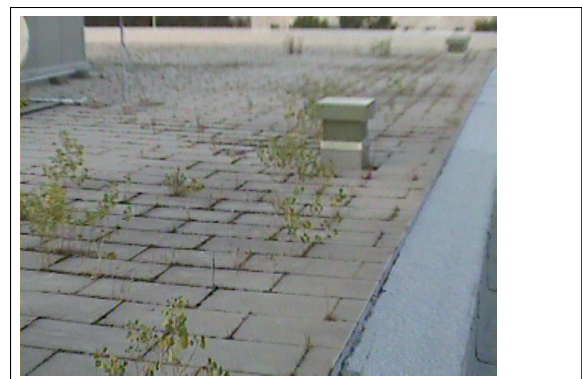
Figure 2. Visual of concrete clad insulation over inverted roof membrane, no visible wetting on concrete.

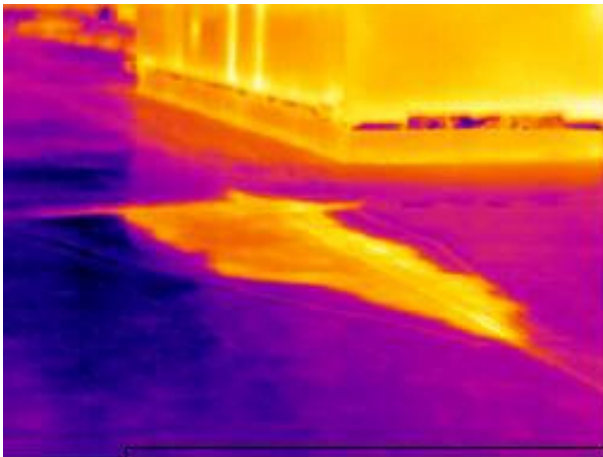
Figure 3. Moisture within insulation under one ply sheet membrane roof assembly as seen from exterior (Images courtesy of ITC)

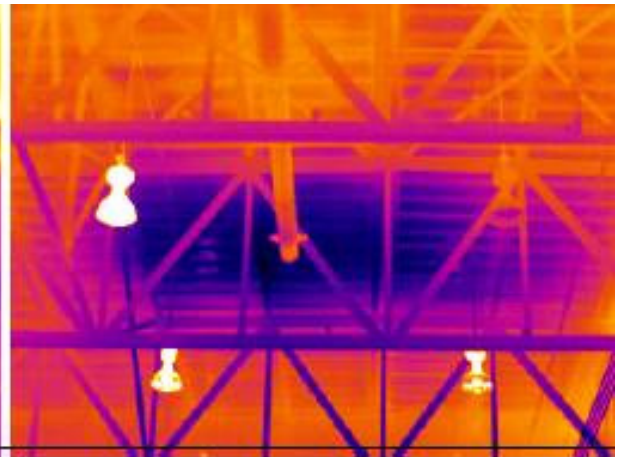
Figure 4. Moisture within insulation as seen from interior of building. Image courtesy of David Felletti, WJE)

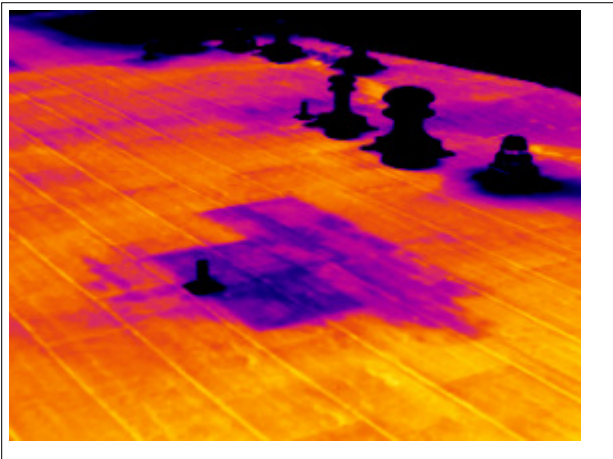
Figure 5; Moisture within insulation as seen from an adjoining roof taken at 11:22am in the morning. (Image courtesy of Lee Durstin, BCRA)

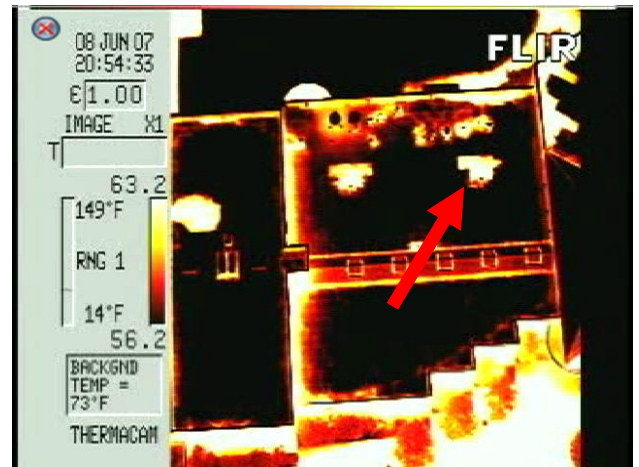
Figure 6; Same area shown in Figure 5 (see arrow) taken at 8:54pm in the evening during a flyover. (Image courtesy of Lee Durstin, BCRA)

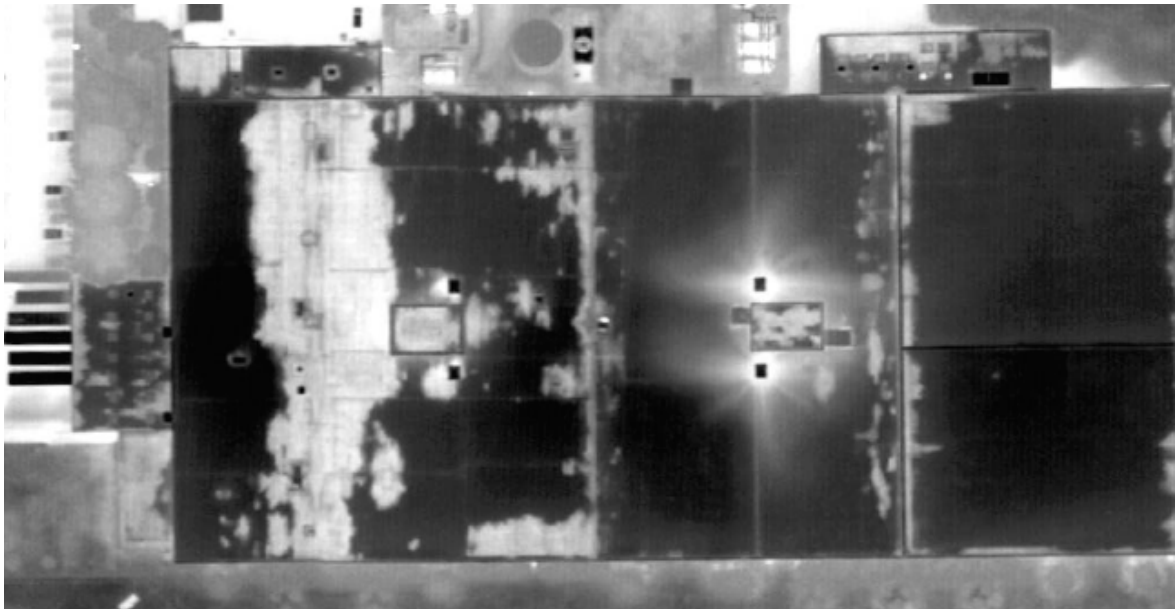
Figure 7. Aerial infrared image of moisture within insulation of conventional built-up roof. Note only one section of three requires replacement. The other two roof sections display minor roof leaks around curbs and flashings. (Courtesy of AITScan and Stockton Infrared, Greg Stockton)

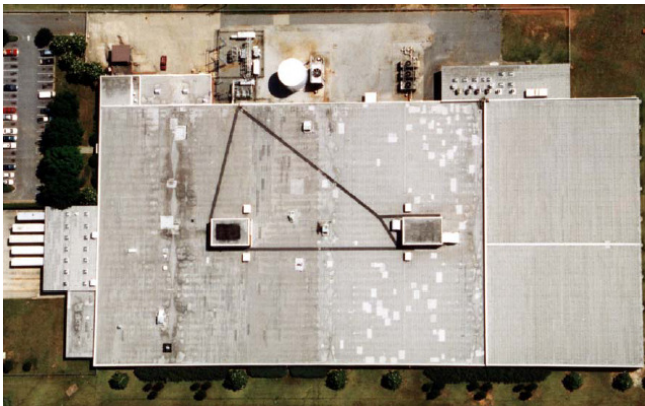
Figure 8. Visual aerial photo. (Courtesy of AITScan, Greg Stockton)

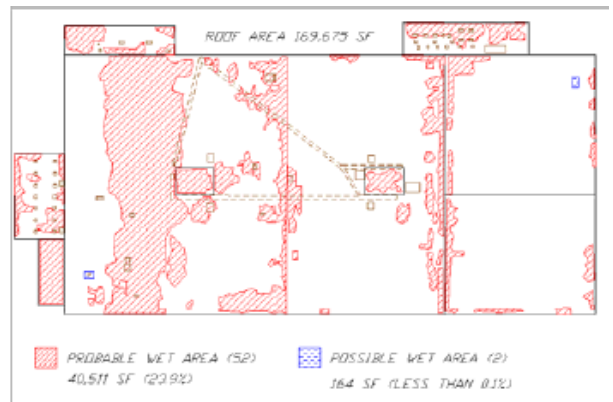
Figure 9; CAD drawing of suspected moisture. (Courtesy of AITScan, Greg Stockton)

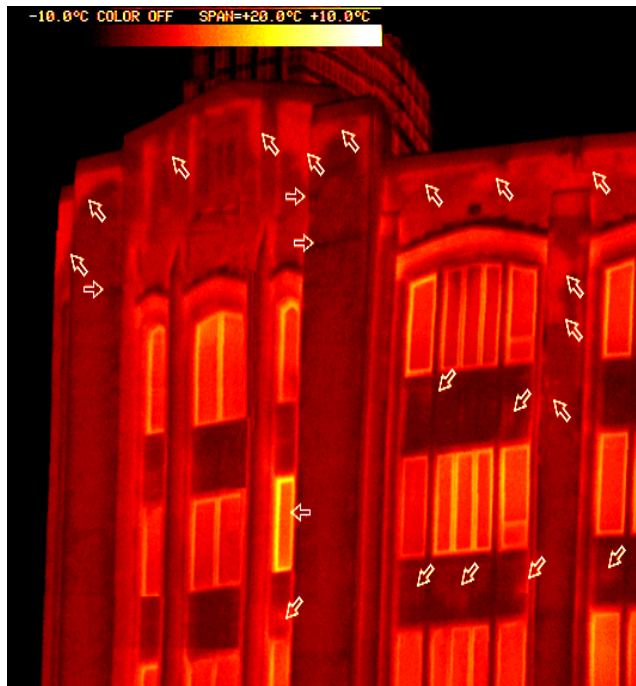
Figure 12. Rain Water Penetration at Parapets. Negative Building Pressure (-20 Pa).

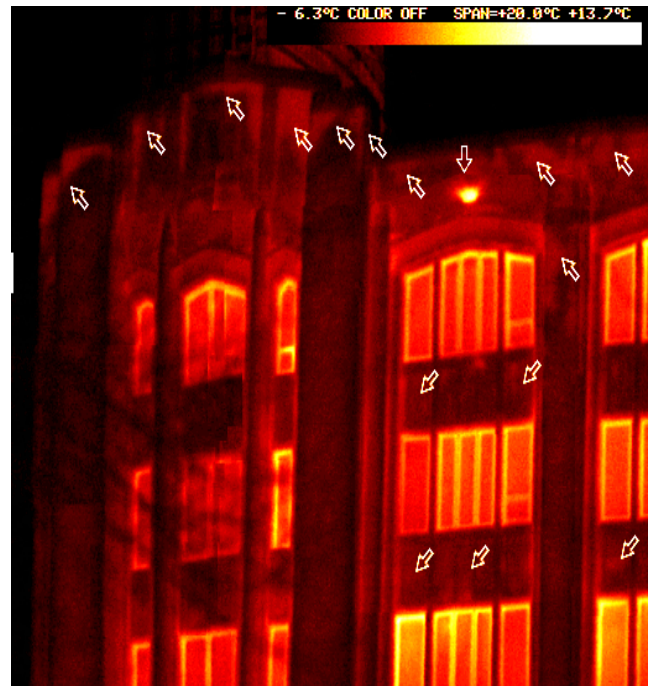
Figure 13; Rain Water Penetration at Parapets. Positive Building Pressure (+35 Pa)

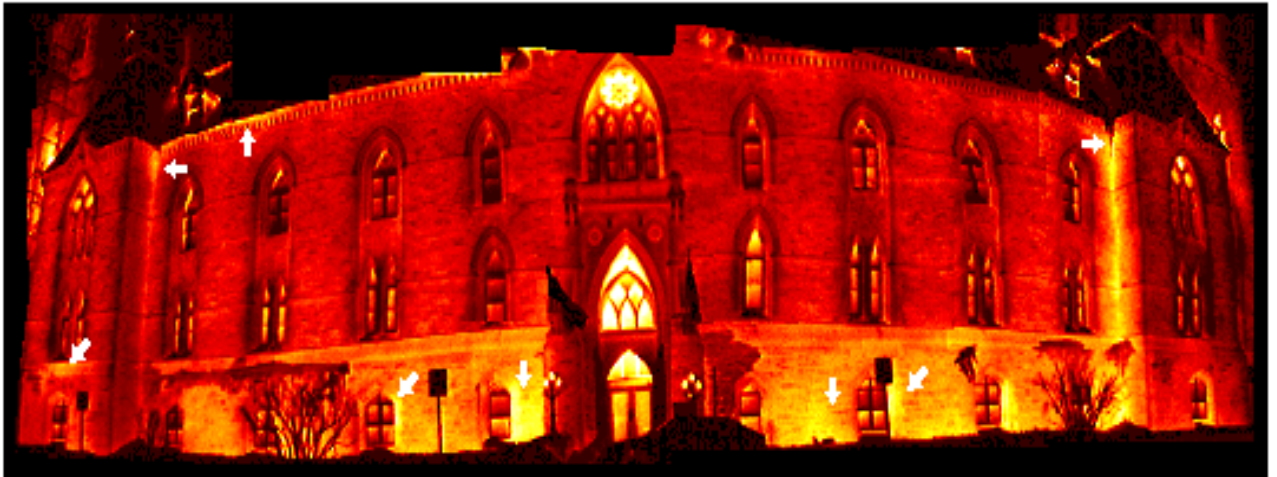
Figure 14. Ground floor of solid masonry wall assembly illustrates warmer surface temperatures due to rising damp from ground water in foundation wall. Melt water penetration into walls also visible at inside corner on right side of image.

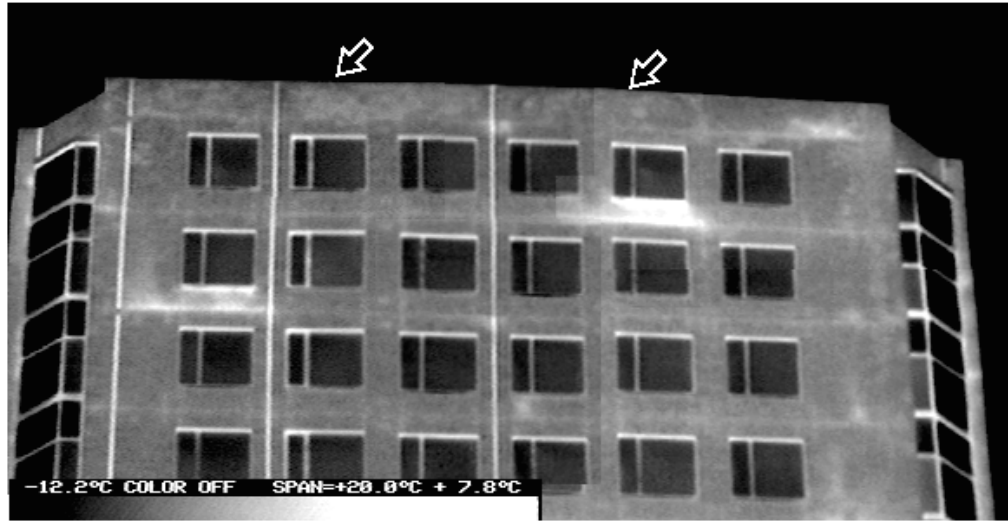
Figure 15. Positive Building Pressure (80 Pa), To = -7 °C (19.4 °F), maintained for a duration of 5 hours prior to inspection.

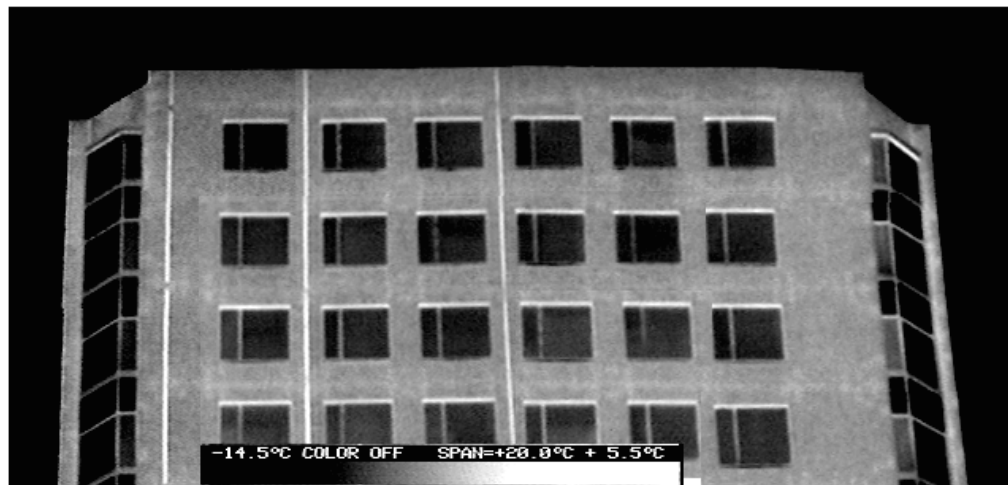
Figure 16. Negative Building Pressure (-60 Pa), To = -7 °C (19.4 °F), maintained for a duration of 4 hours prior to inspection.

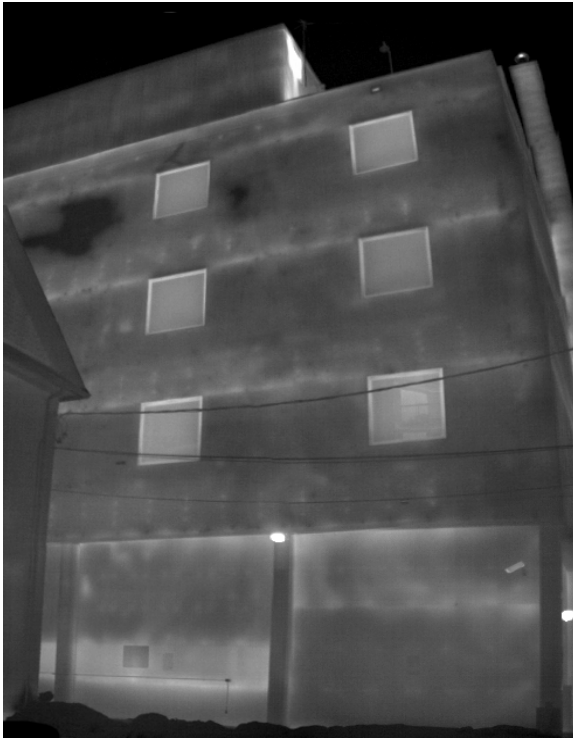
Figure 17. Negative Building Pressure (-140 Pa), $T_o = 0\text{ }^{\circ}\text{C}$ (32 °F)

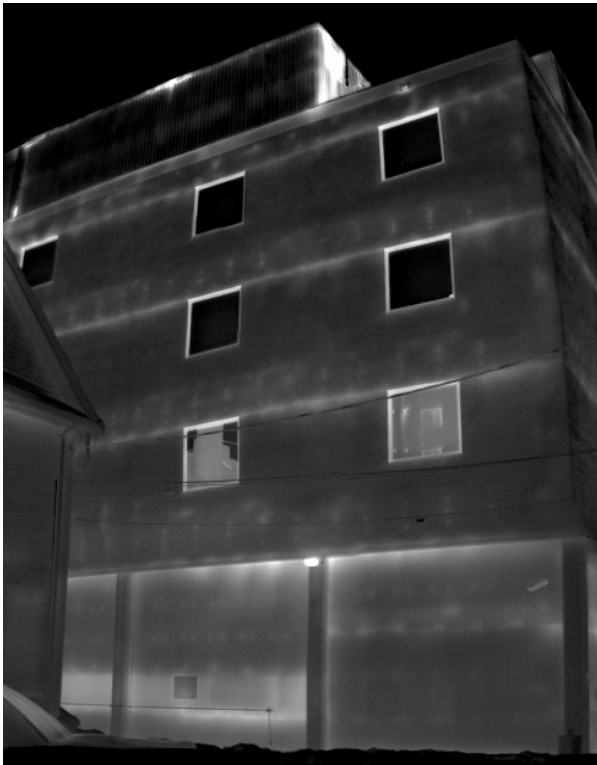
Figure 19. Negative Building Pressure (-8 Pa), To =-11 °C (12.2 °F)

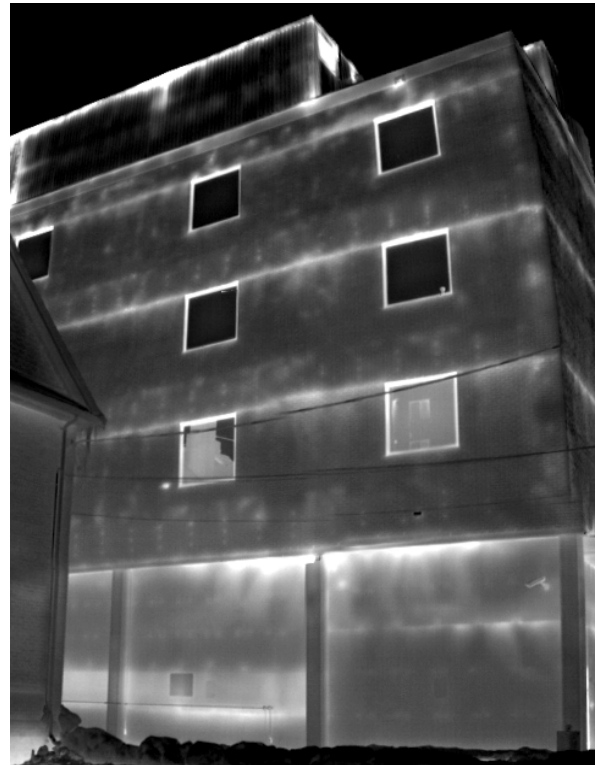
Figure 20. Positive Building Pressure (+25 Pa), To =-11 °C (12.2 °F)

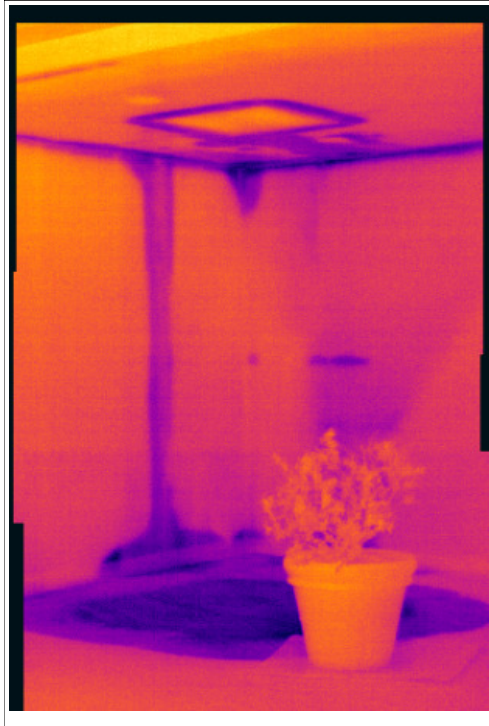
Figure 21. Fire sprinkler system leak observed on an interior painted wall and carpet. Initial wetting and drying appear much defined.

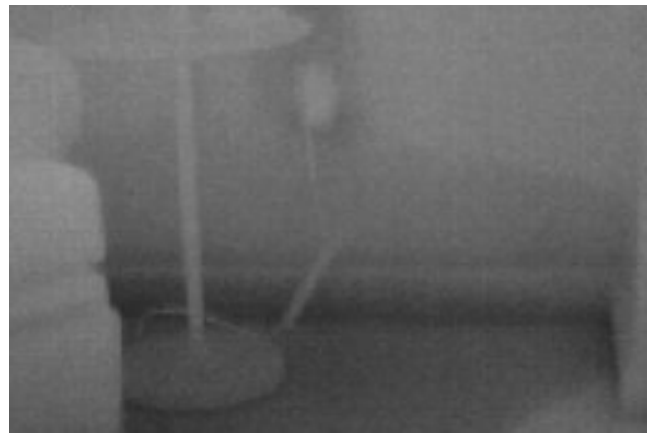
Figure 22. Wetting patterns may be minimal if covered with vinyl wallpaper that inhibits evaporative cooling.

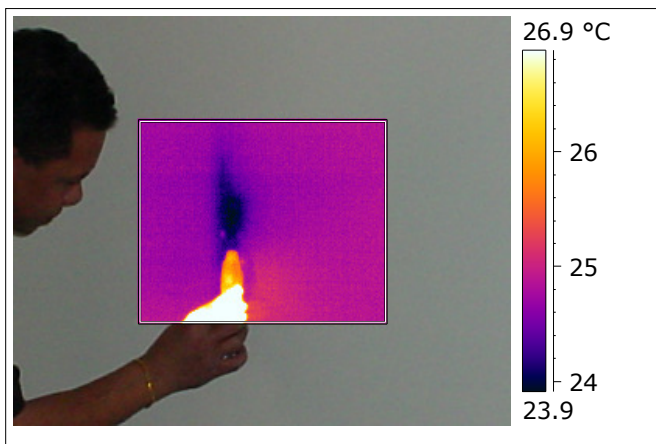
Figure 23; Confirming moisture presence with a capacitance moisture meter.

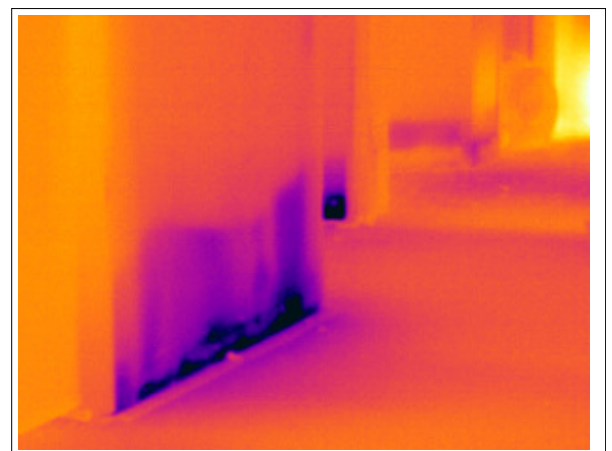
Figure 24; Locating and documenting wet areas.

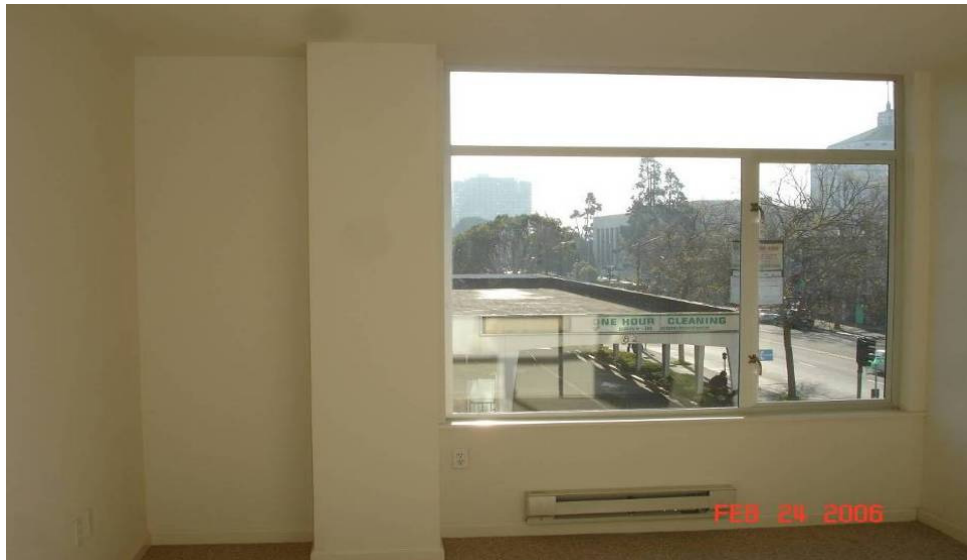
Figure 25. Interior surfaces of exterior walls showing no visible wetting other than flooring.

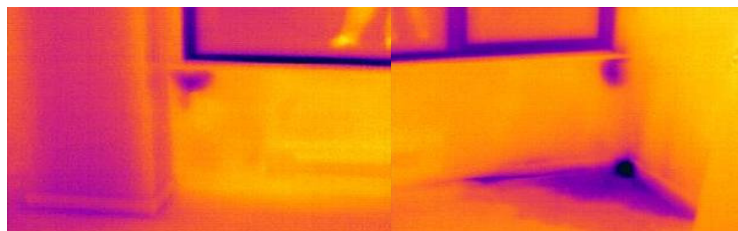
Figure 26. Rain water penetration into wall below corners of windows and on floor area on right side of thermal image.

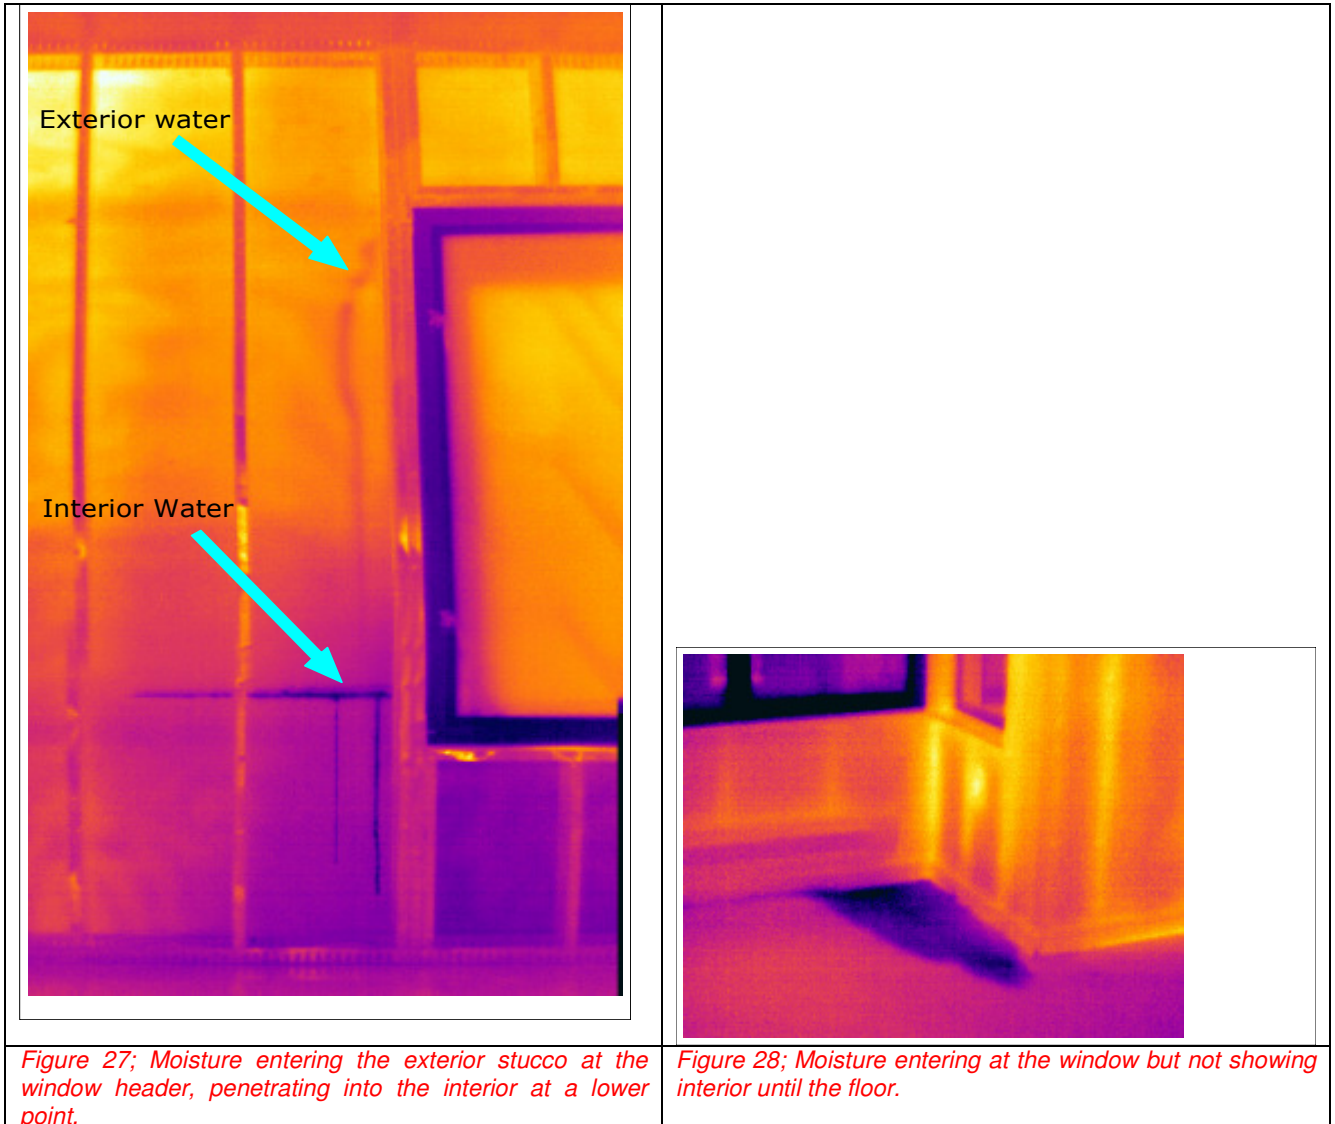
INTERIOR INSPECTIONS; MOISTURE PATTERNING DUE TO RISING DAMP

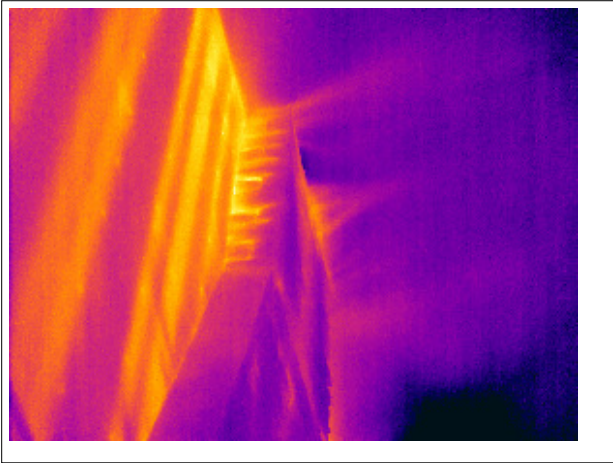
Figure 29; Air infiltration during pressure testing. (Image courtesy of Lee Durstin, BCRA)

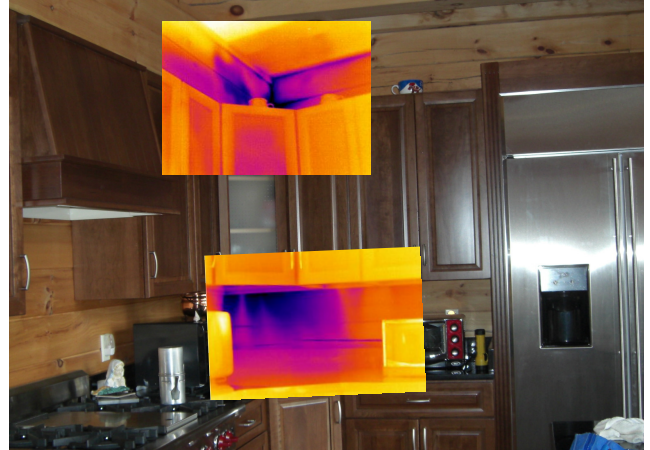
Figure 30; Air infiltration during pressure testing. (Image courtesy of Janet Vics, Infrared investigation)

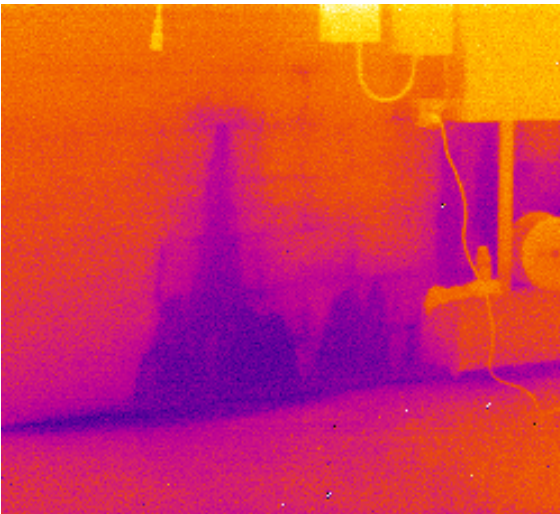
Figure 31. Ground water penetration into hollow core block foundation wall.
